# Manhole Inspection Summary

Manhole # **S39S\_\_050MH**

Record Plat: **39S** Node: **050** Status: **New Manhole (Not in GIS)** Insp Date: **1/15/08 2:12 PM**

**Location** Address: **unnamed alley**

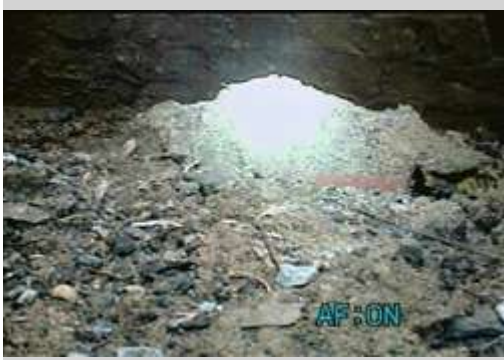
Defect 2

Condition: ☐ Sound ☐ Cracked ☐ Root Intrusion ☐ Deteriorated ☐ Leaks ☒ **Debris**

channel debris

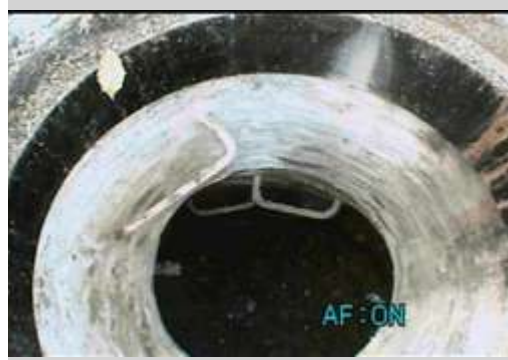
Defect 1

Count: **5** Missing: **1** ☒ **Corroded**

corroded steps
